# FIELD TESTING FOR RELIABILITY ASSESSMENT OF NEW CPV TECHNOLOGIES

Mark Spencer<sup>1</sup>, Marc Finot<sup>2</sup>

<sup>1</sup> SolFocus, Inc., Mountain View, CA

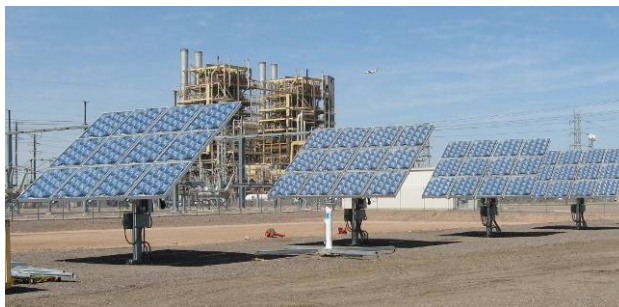
Figure 1. Four of the five SolFocus 2.5 kW arrays at the APS-STAR center in Tempe, AZ.

Solfocus established one site at the Arizona Public Service, Solar Test and Research (APS-STAR) center in April of 2007. The field data presented in this paper is from the APS-STAR site. The site consists of five grid-connected 2.5kW arrays mounted on two-axis tracking systems (Fig. 1). Several of the arrays there have been continually functioning for the past 12 months. Three distinct populations of CPV panels have been installed and tested at the site. Early prototype units showed rapid performance deterioration and were replaced with improved models. These updated models have been continually operating for almost a year with no detectable performance deterioration.

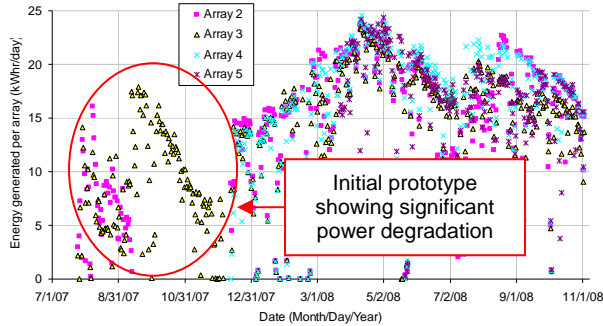
Figure 2. Daily energy generation of SolFocus arrays at the APS-Star center.

Array level performance has been monitored over the last 15 months. The energy generated per day is shown in Fig. 2 for arrays 2 through 5. Array #1 was never fully populated and is not included here. Arrays 2 and 3 were installed in mid-July of 2007. After good initial performance, the power output severely degraded within a few weeks. The failure mode, which was attributed to an inadequate coating on the secondary mirror, detailed in the following section, had not been observed in panels that had been already operating in the San Francisco region for 4+ months. This illustrates the difficulty of detecting different failure modes based on standard acceleration factors.

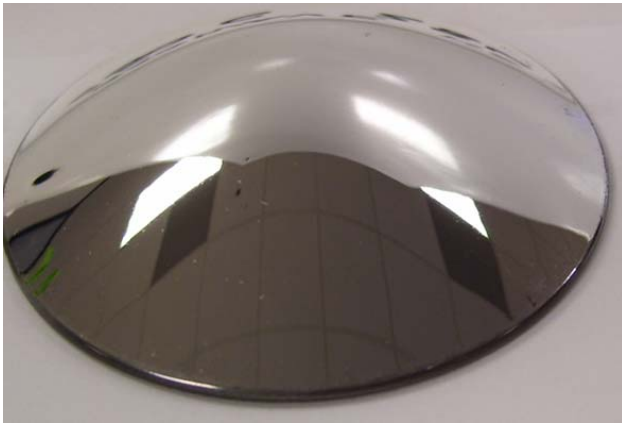
Figure 8. Secondary mirror coating #3 after 1000 hours at 250°C. No indications of failure.

Coating #3 was identified as the preferred mirror coating for large scale production of the SF1000 and SF1100 panels. All panels at customer sites, such as the 200kW and 300kW ISFOC installations [4], use secondary mirrors with this coating. While life tests are not complete, SolFocus has a high confidence in 20+ year lifetime from

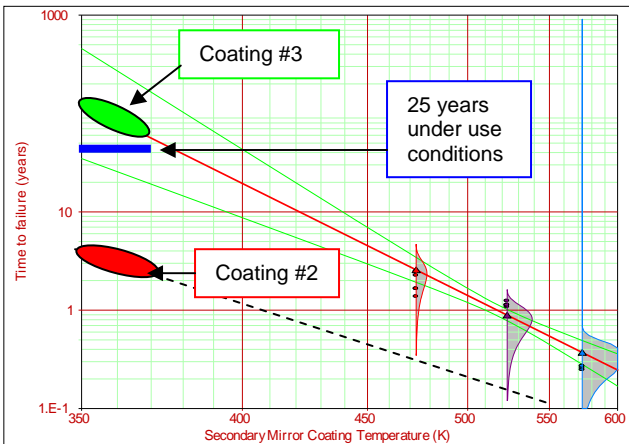
In order to improve the life estimates and gather kinetic reaction rates for this mechanism, the high temperature storage tests were expanded to multiple levels for coatings #2 and #3. The temperature levels used for these tests were 200°C, 250°C and 300°C. In this test program, the end of life is defined as a 5% reduction in the light throughput across the secondary mirror. The collimated flash solar simulator described by Askins, et.al. [3] is used to conduct these measurements. The secondary mirrors under test are placed in a common reference SF1000 power unit. Thus we are able to get the relative performance of the individual component within the overall SF1000 optical path. Due to the relative robustness of Coating #3, these tests are still in progress. Preliminary results for Coating #3 are shown in Figure 9.

Figure 9. Secondary mirror coating life test results (preliminary) – extrapolating to standard operating temperatures (350 to 375K).

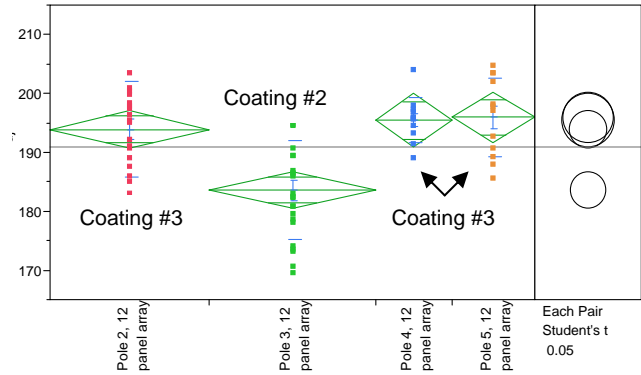
the rigorous test program and acceleration model. The majority of panels at the APS-STAR site use this coating and have not shown any degradation after a year of operation. Half of the panels on Array #3 at APS-STAR have the inferior Coating #2. These panels were kept operating in order to verify the life model developed during the accelerated high temperature exposure test program. Figure 10 shows that the coating #2 panels on array #3 are performing at a statistically significant lower level after approximately 1.2 years at the site.

Figure 10. Comparison of the individual panel power distribution after 15 months (Array #3), 10 months (Arrays #2, 4) and 6 months (Array #5) of operation.

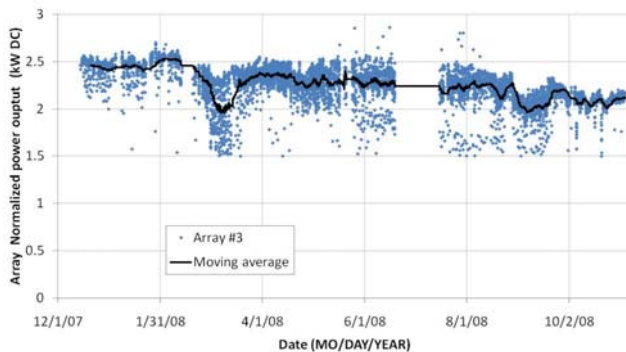
Array #3 is a good vehicle to use to start to understand the relationship between distributed failures of components within a system and the overall performance of the system. Figure 11 shows the normalized power output for Array #3 which has 7 of the 12 panels with the inferior coating #2 on the secondary mirrors. Figure 10 also shows the individual power output distribution of the modules on this array. Once the degradation of these panels gets to a predetermined level, they will be removed from the system and tested in detail to quantify degradation of each power unit. This information will be used for system performance model validation.

Figure 11. Normalized DC power output for array #3 (DNI > 600 W/m<sup>2</sup>).
